**TARGETED BROWNFIELDS ASSESSMENT
ASBESTOS CONTAINING BUILDING MATERIALS AND
LEAD-BASED PAINT INSPECTIONS**

**Fort Wolters Texas Department of Criminal Justice Property
16.37 Acre Tract at the Southeast Corner of Cross Post Rd. and Grant Rd.
Mineral Wells (Parker County), Texas 76067**

Report Date: October 21, 2010

dse Project N^o : 1037503

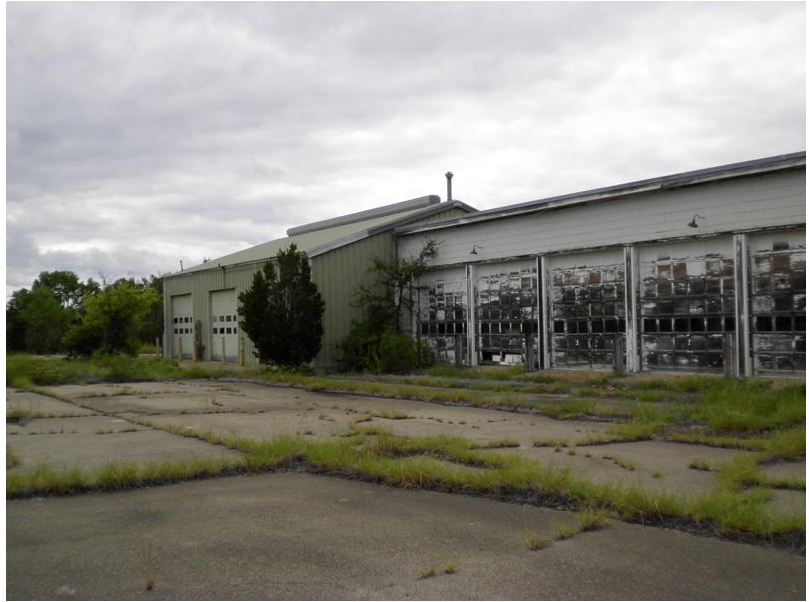
Exterior view of Building 540 showing Transite identified as ACBM.

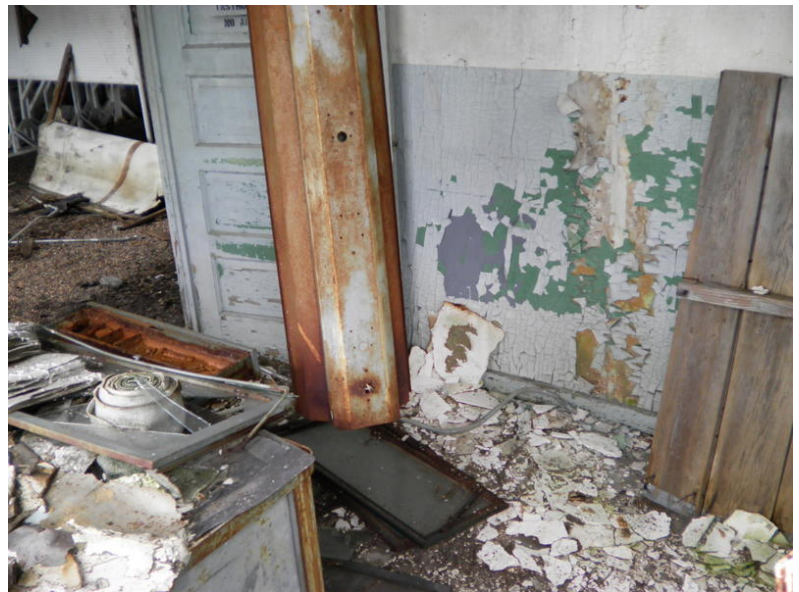
PHOTO 2 ►

Paint texture identified as ACBM at office interior of Building 540.

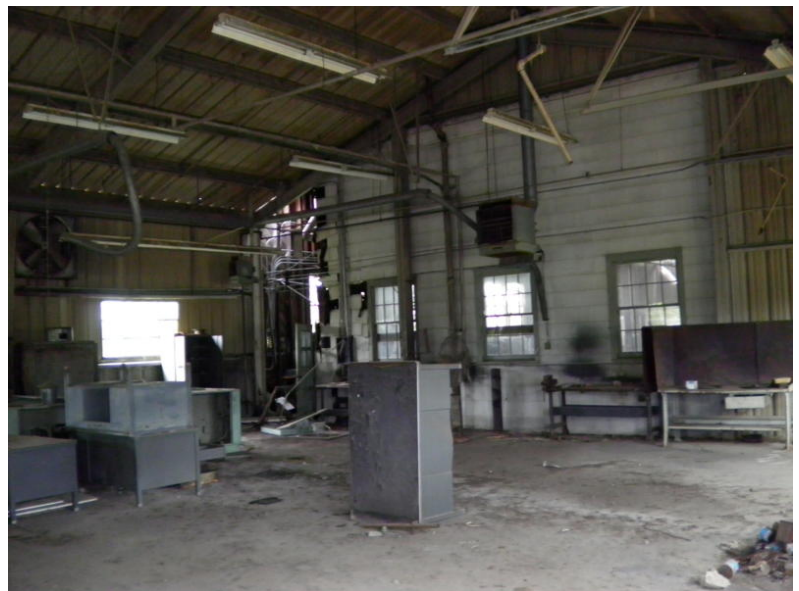
PHOTO 3 ►

Transite identified as ACBM in interior of Building 540.

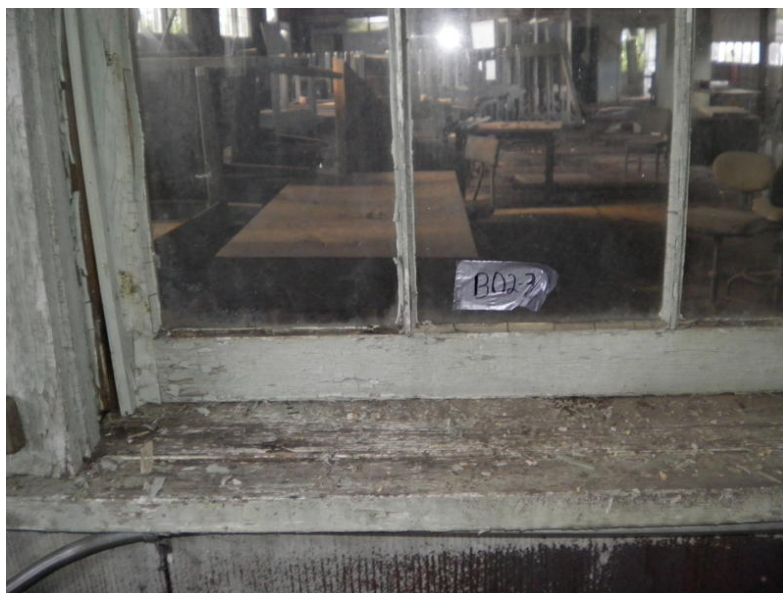
PHOTO 6 ►

Gray window glazing identified as ACBM inside Building 540.

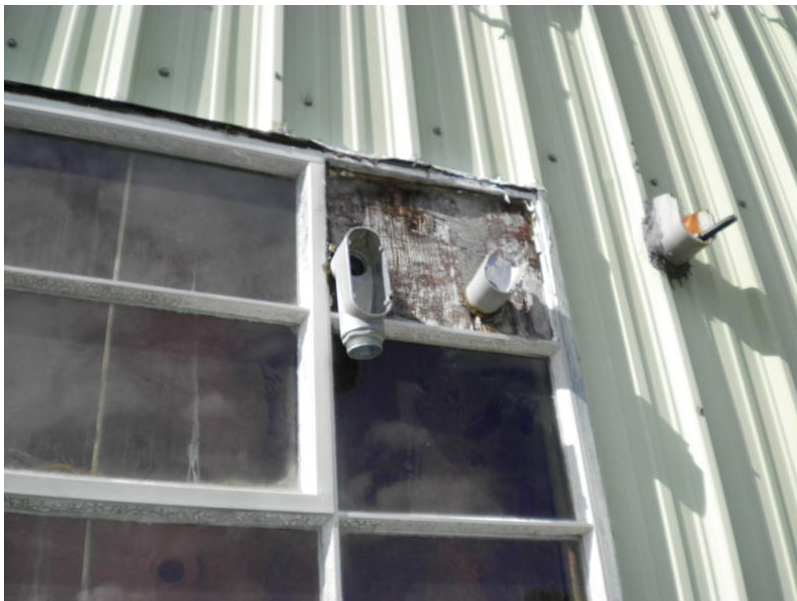
PHOTO 7 ►

White window glazing compound identified as ACBM on exterior of Building 540.

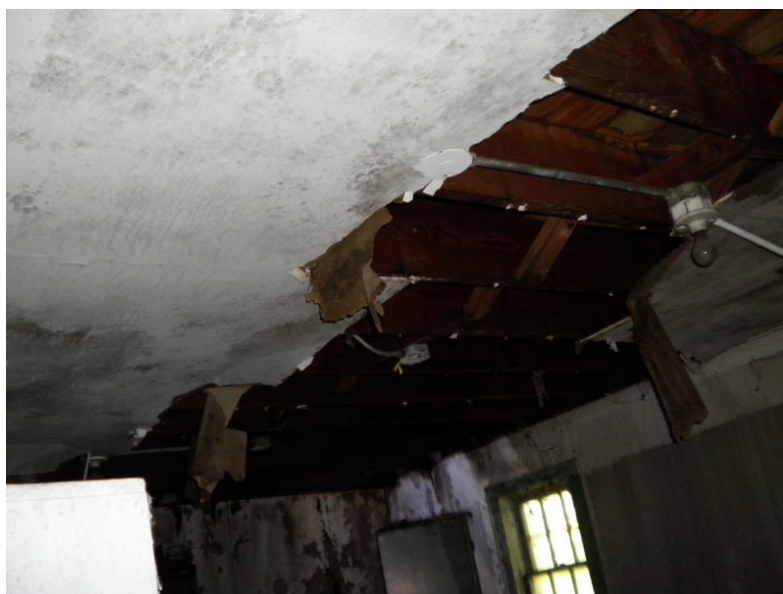
PHOTO 8 ►

Ceiling and wall systems identified as ACBM at Building 540 parts room interior.

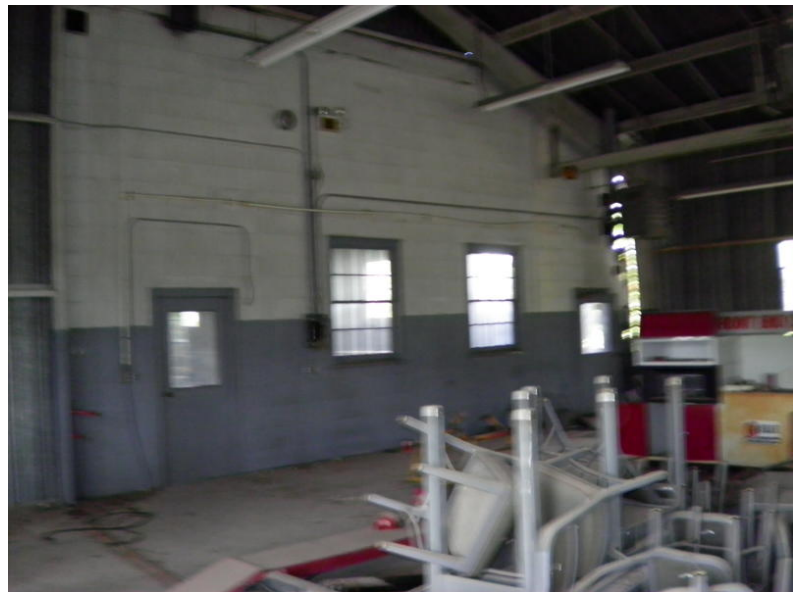
PHOTO 11 ►

Transite identified as ACBM on interior of Building 541.

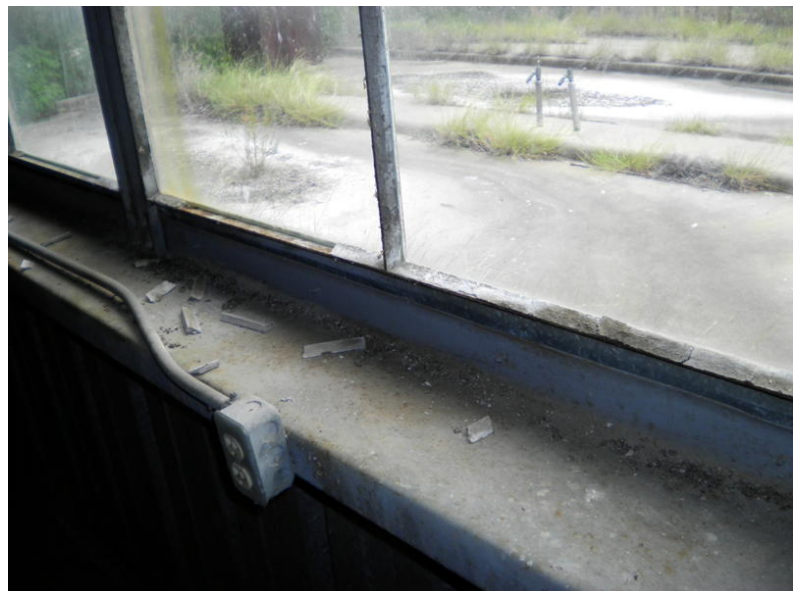
PHOTO 12 ►

Window glazing identified as ACBM in interior of Building 541.

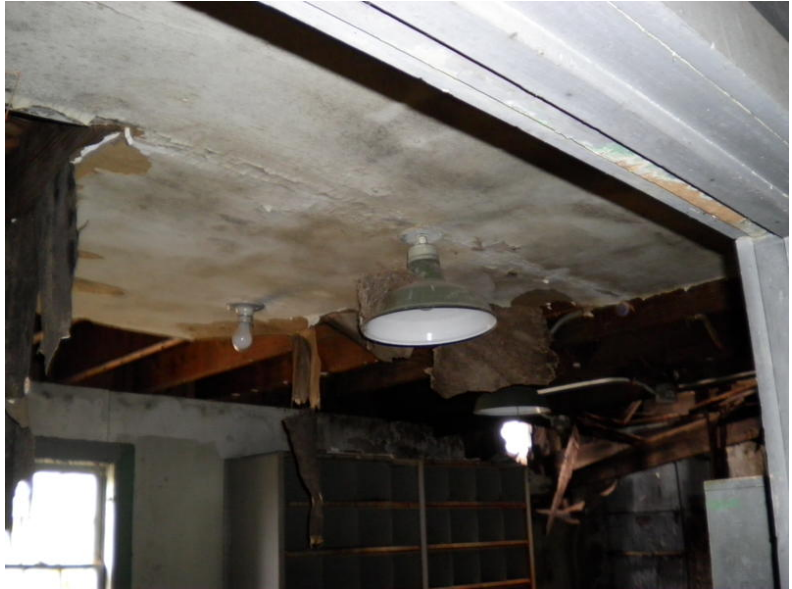
PHOTO 13 ►

Ceiling system containing joint compound identified as ACBM in north center room (parts room) of Building 541.

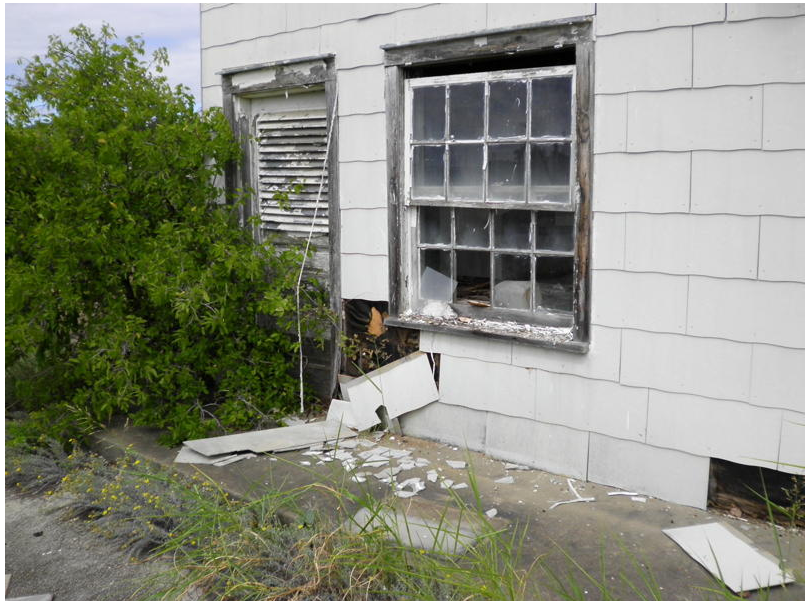
PHOTO 14 ►

Exterior Transite and window glazing identified as ACBM at Building 541.

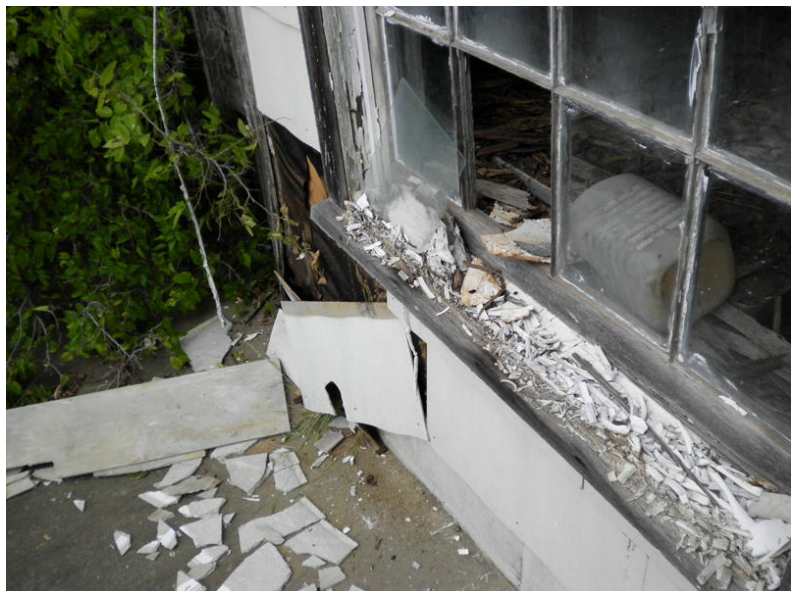
PHOTO 15 ►

Exterior Transite (gray soffit debris and white wall varieties), window caulking, and window glazing identified as ACBMs at Building 541.

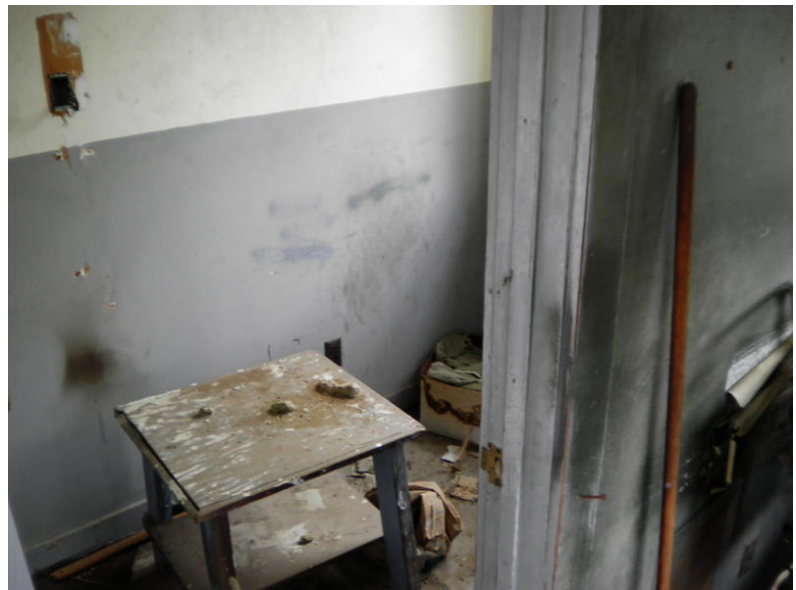
PHOTO 17 ►

Paint texture and joint compound in wall system identified as ACM in Building 578.

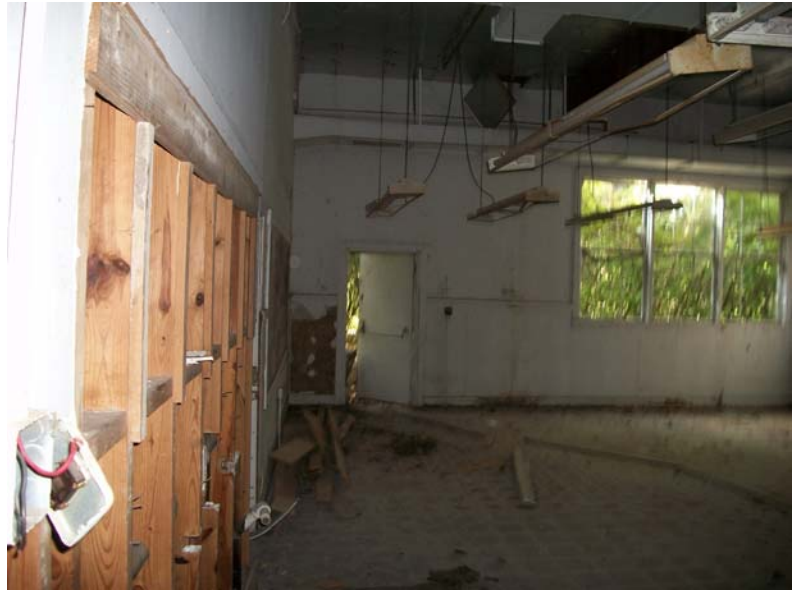
PHOTO 19 ►

Building 551, Room 1. VCT/mastic on floors and joint compound/texture on walls were identified as ACBM's (also in Building 552).

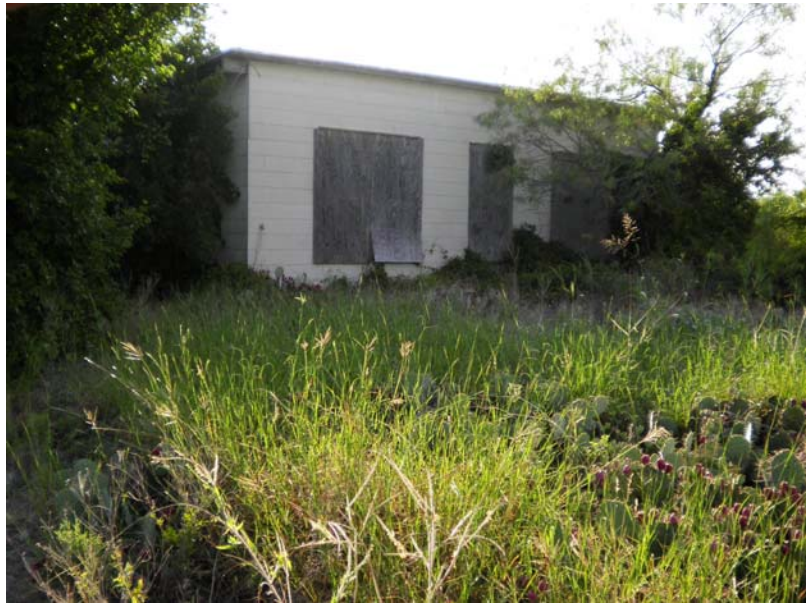
PHOTO 20 ►

Building 551. Transite shingles on building exterior walls were identified as ACBM's (also in Building 552).

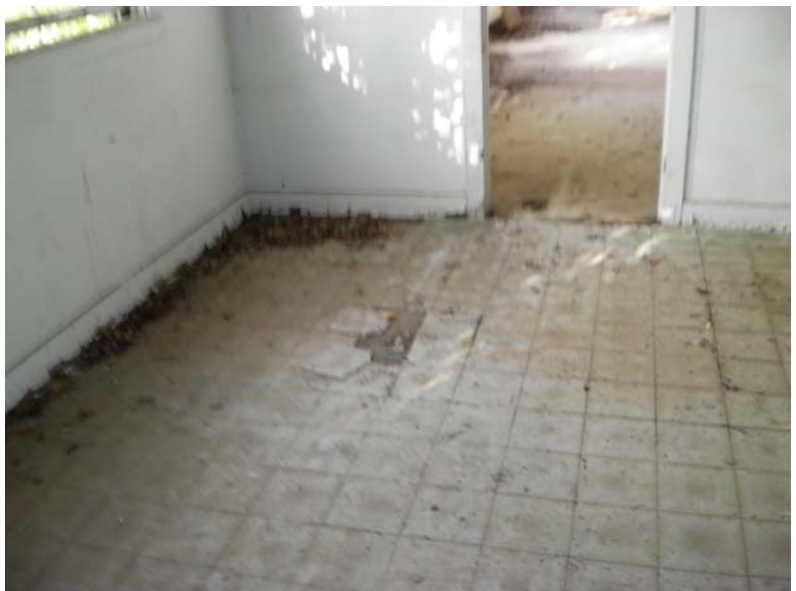
PHOTO 21 ►

Building 551. VCT and mastic on floors were identified as ACBM's (also in Building 552).

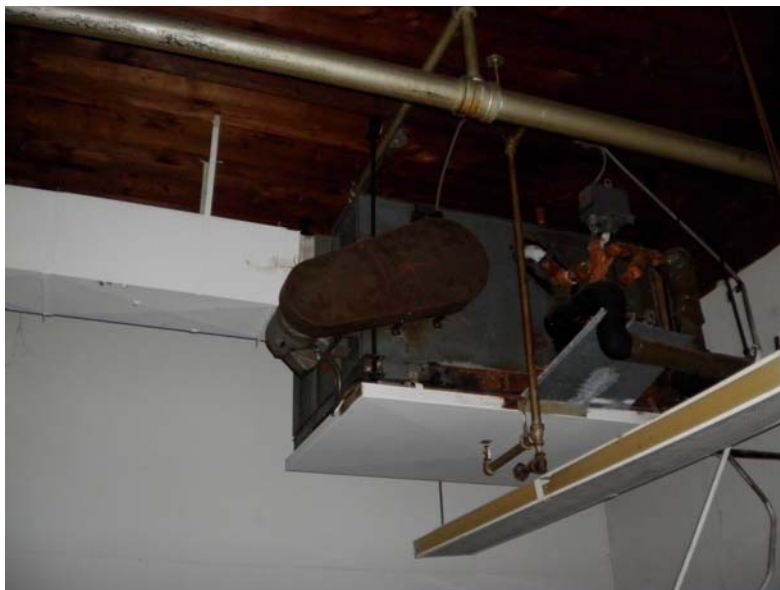
PHOTO 22 ►

Building 551. HVAC vibration gasket on overhead air handling units were assumed to be ACBM's (also in Building 552).

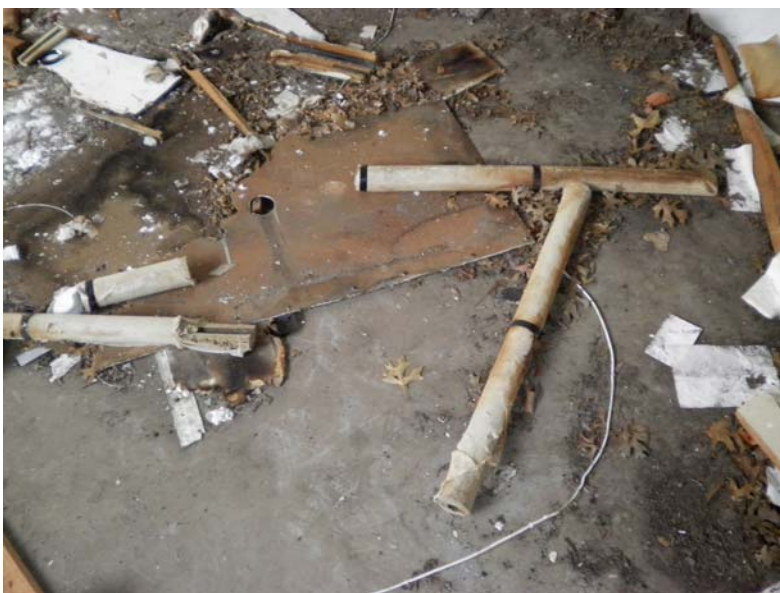
PHOTO 24 ►

Building 551. TSI debris was identified as an ACBM (also in Building 552).

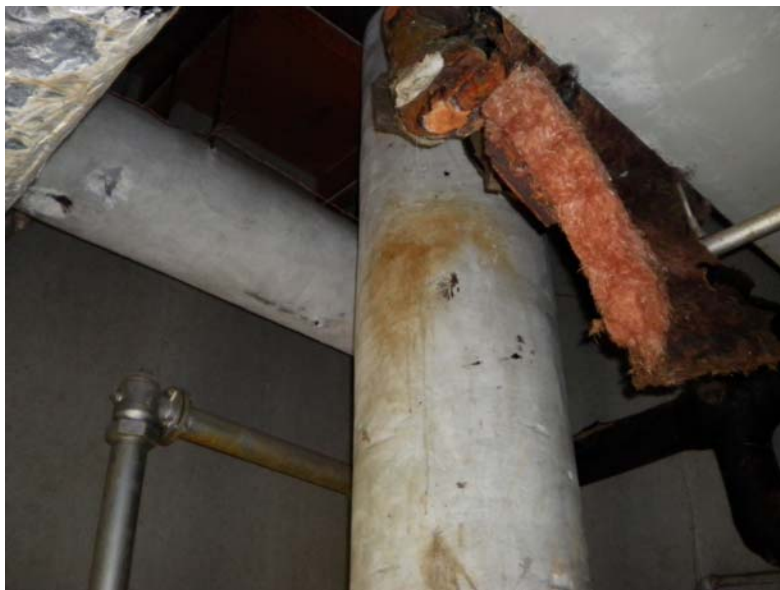
PHOTO 25 ►

Building 551. TSI on furnace, flue and overhead vessel were identified as ACBM's (also in Building 552).

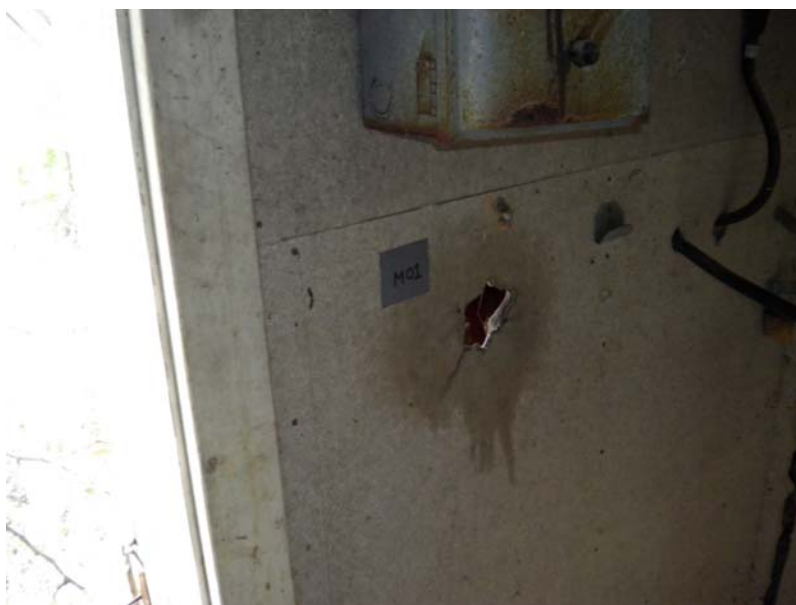
PHOTO 26 ►

Building 551. Transite panels on interior walls of boiler room were identified as ACBM's (also in Building 552).

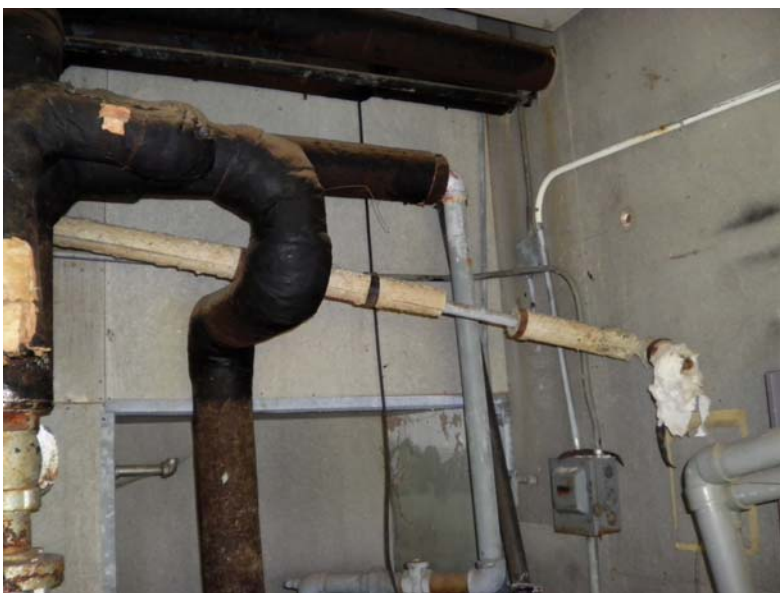
PHOTO 27 ►

Building 551. TSI on piping was identified as an ACBM (also in Building 552).

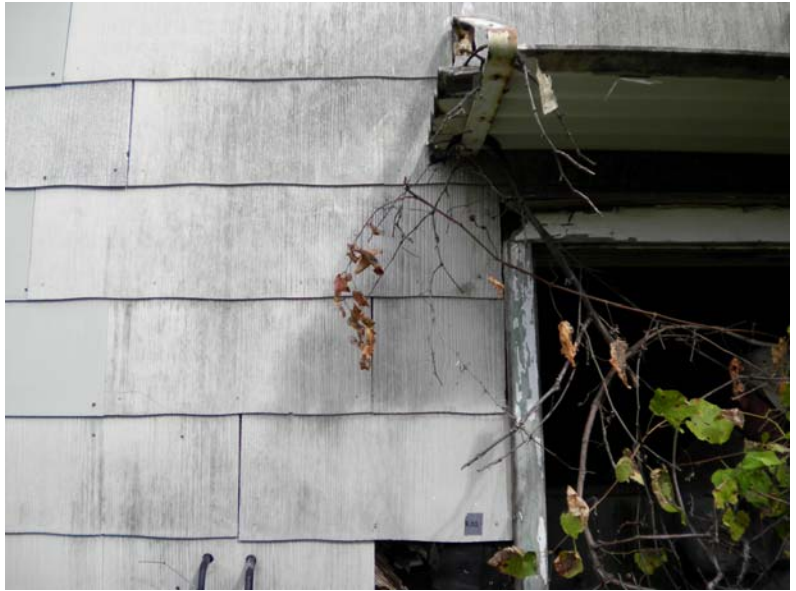
PHOTO 28 ►

Building 551. Corrugated Transite panels above exterior doors were identified as ACBM's (also in Building 552).

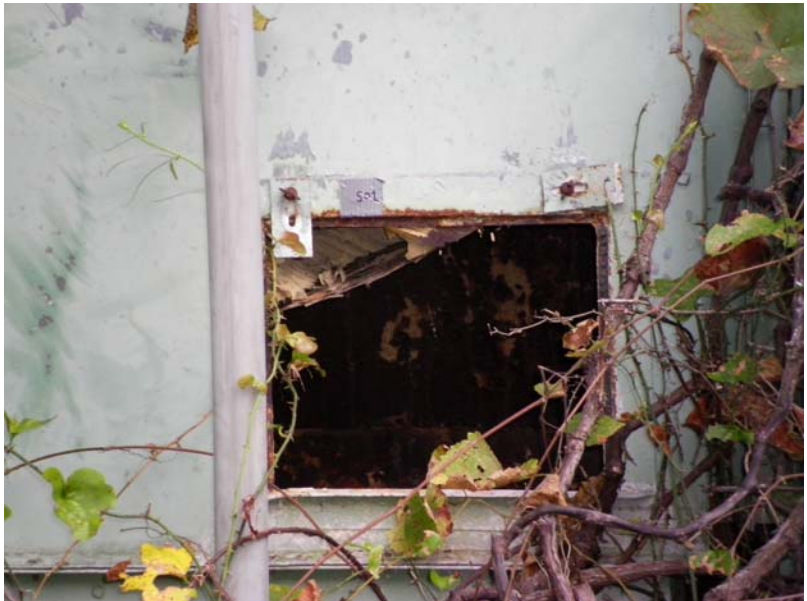
PHOTO 29 ►

Building 551. Internal baffling inside cooling tower located south of the building was identified as an ACBM (also south of Building 552).

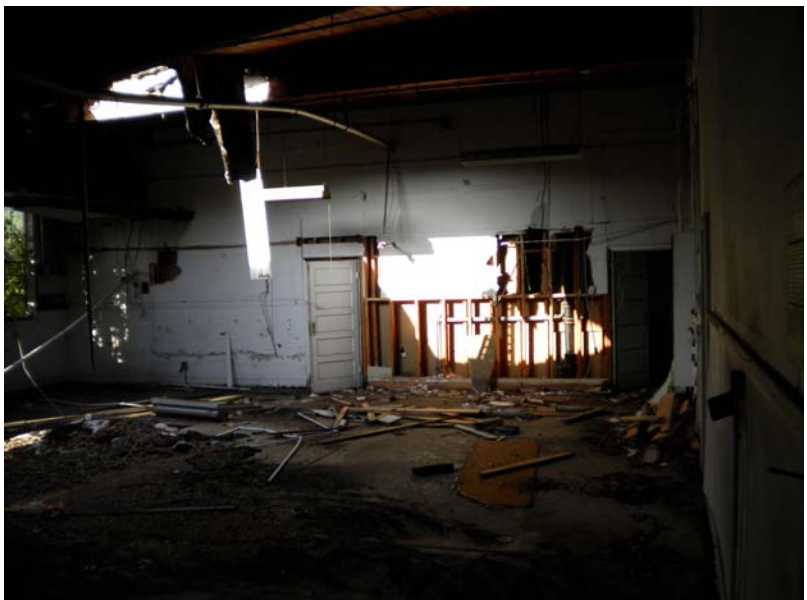
Building 551. Joint compound/texture on drywall was identified as an ACBM (also in Building 552).

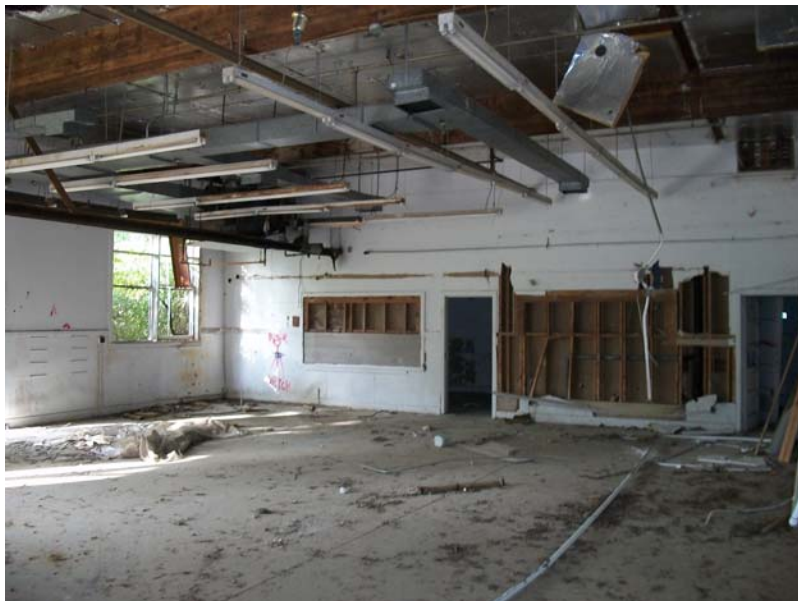
PHOTO 31 ►

Building 552, Room 5. Joint Compound/texture on drywall was identified as an ACBM (also in Building 551).

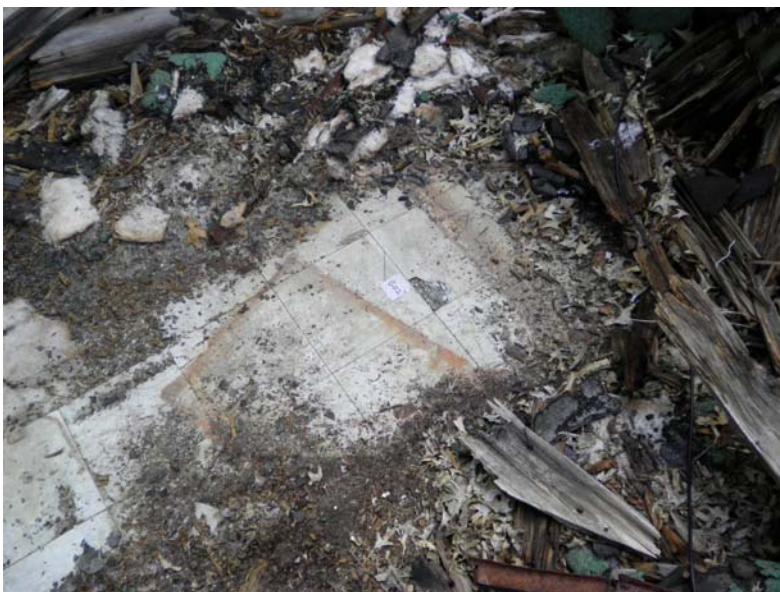
PHOTO 32 ►

Building 571. VCT and mastic on floors were identified as ACBM's.

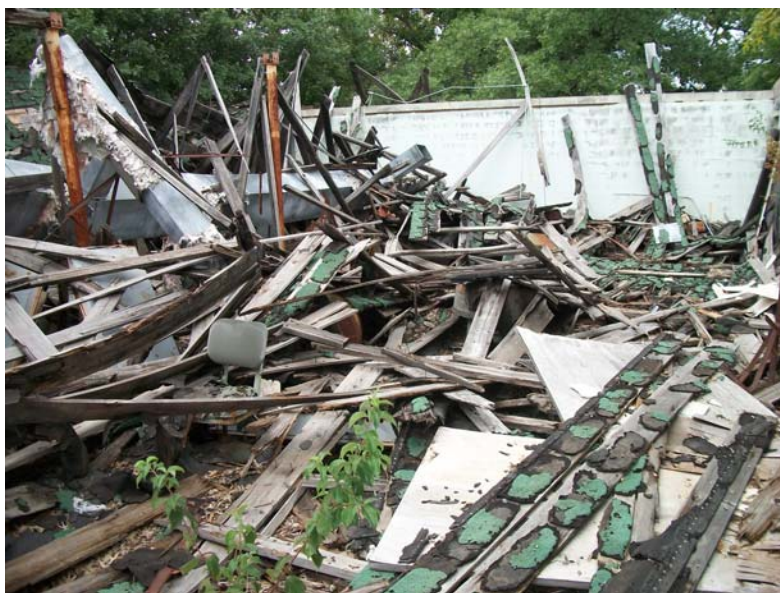
PHOTO 33 ►

Building 571, Room 4. Roofing debris was identified as an ACBM.

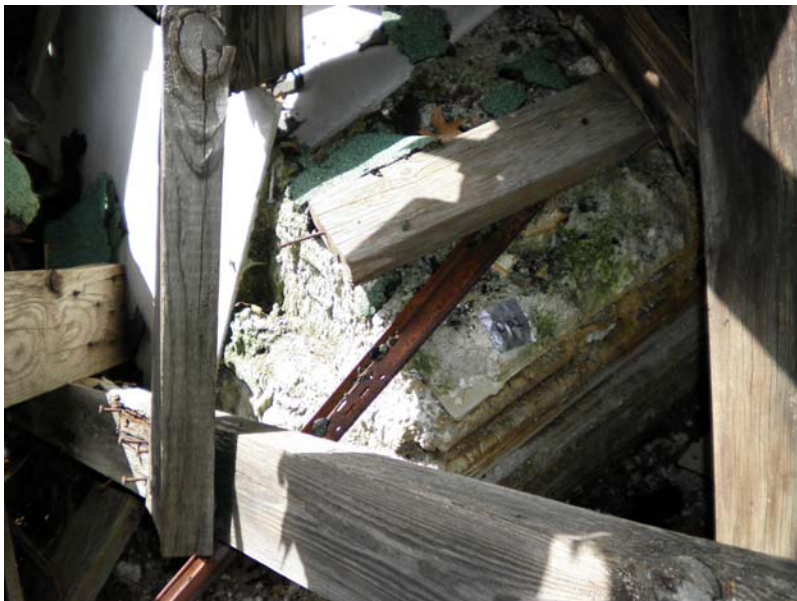
PHOTO 34 ►

Building 571. Acoustical ceiling tile debris was identified as an ACBM.

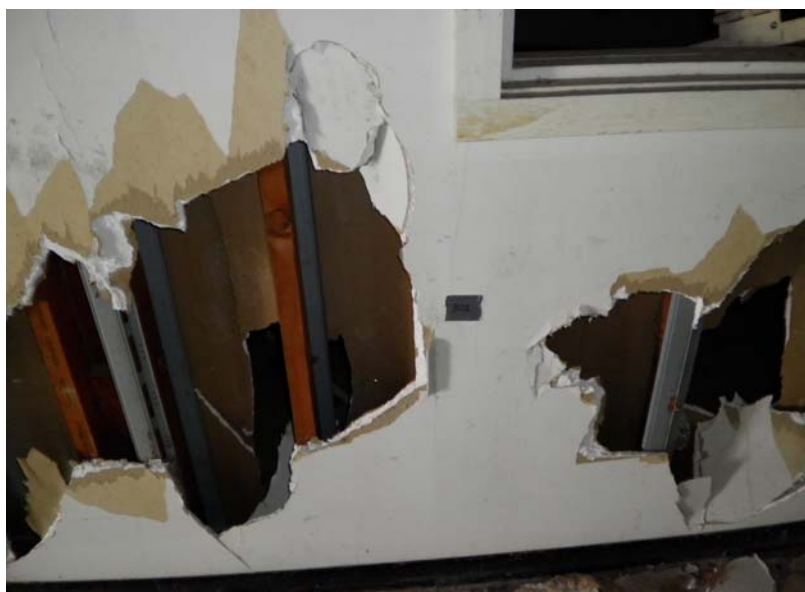
PHOTO 35 ►

Building 575. Joint compound/texture on drywall was identified as an ACBM.

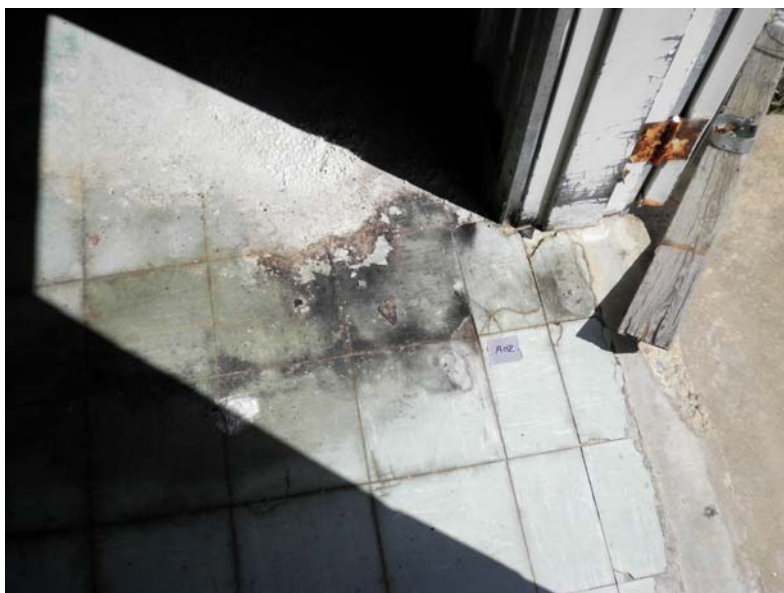
PHOTO 36 ►

Building 575. VCT and mastic on floors were identified as ACBM's.

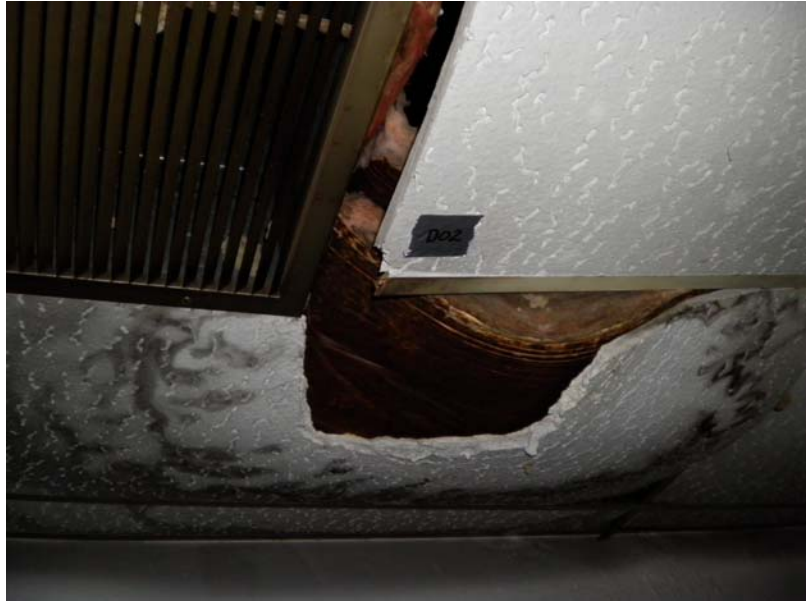
PHOTO 37 ►

Building 575. All of the acoustical ceiling tile (ACT) in the building, except Room 8, was identified as an ACBM.

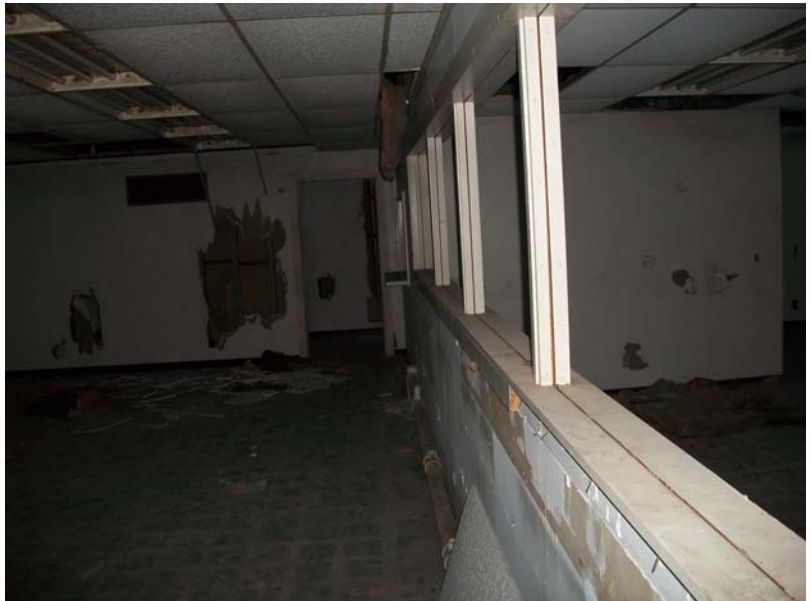
PHOTO 38 ►

Building 575. Devising wall between Room 9 on the left and Room 8 on the right. ACT in Room 9 was identified as an ACBM. No asbestos was detected in the ACT in Room 8.

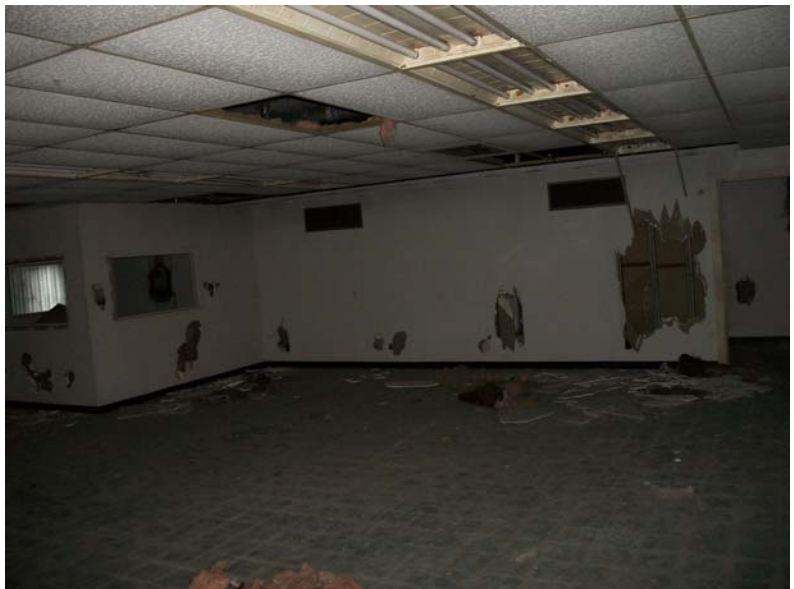
PHOTO 39 ►

Building 575, Room 9. ACT, joint compound/texture on dry-wall, and VCT/mastic on floors were identified as ACBM's.

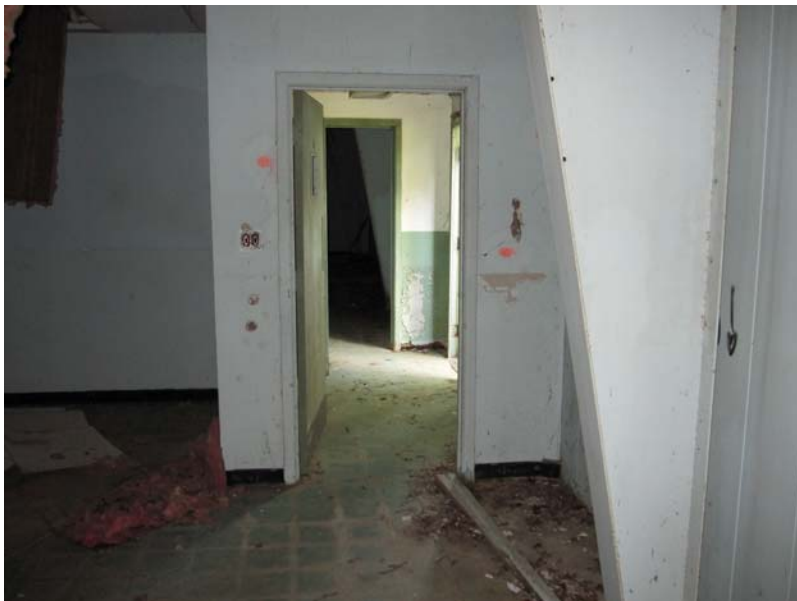
PHOTO 40 ►

Building 576. VCT and mastic on floors were identified as ACBM's.

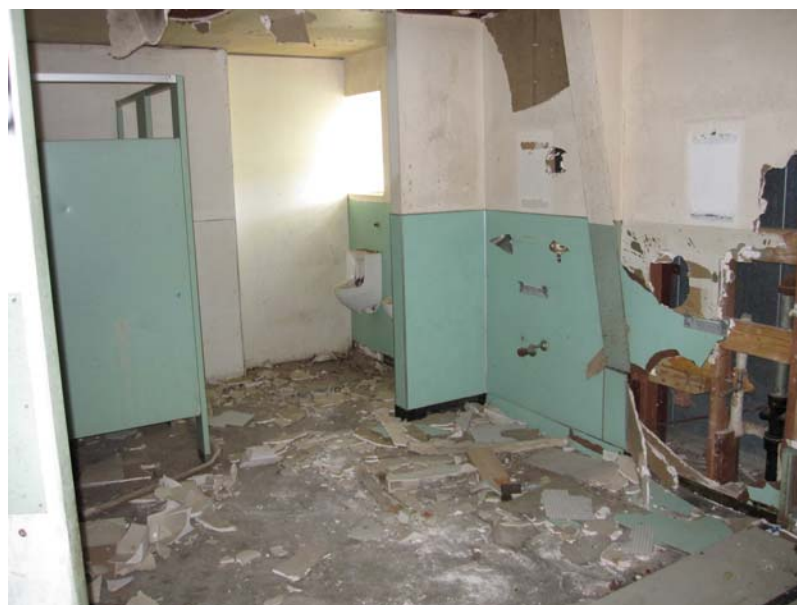
PHOTO 41 ►

Building 576. Joint compound/texture on drywall and wall panel mastic were identified as ACBM's

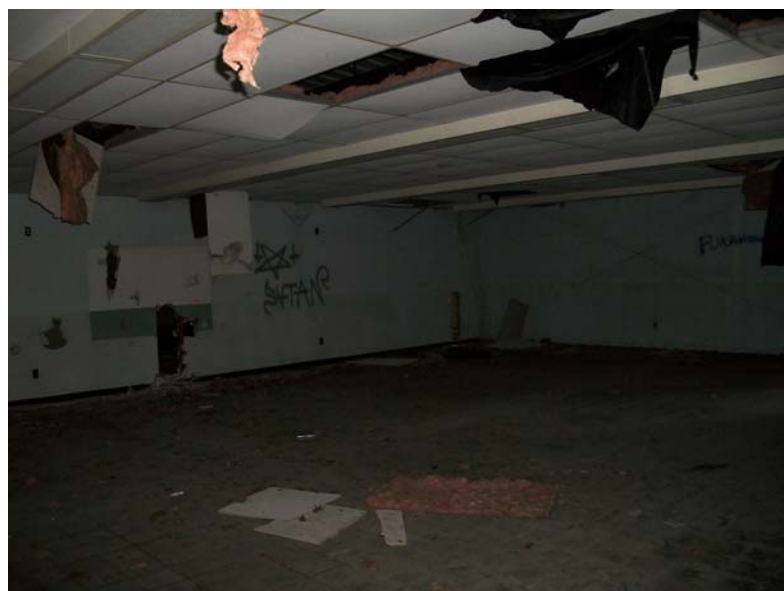
PHOTO 42 ►

Building 576, Room 8. Joint compound/texture on drywall and VCT/mastic on floors were identified as ACBM's.

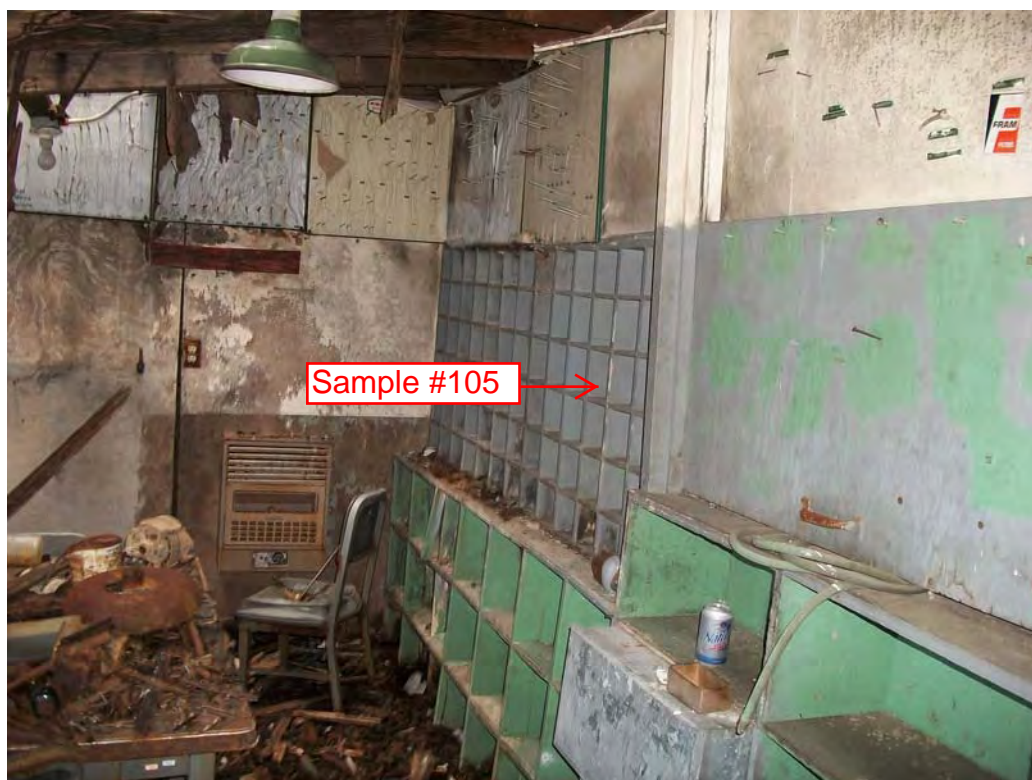
Photo 25 ►

Building 541 - Wood
Building, Room 2.

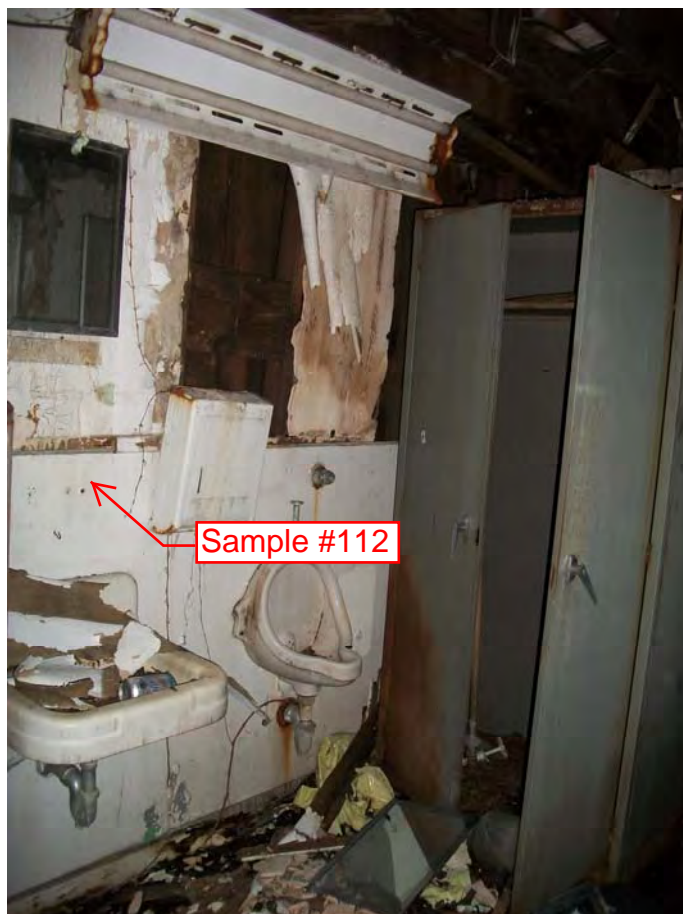
Photo 27 ►

Building 552 - Room 1.

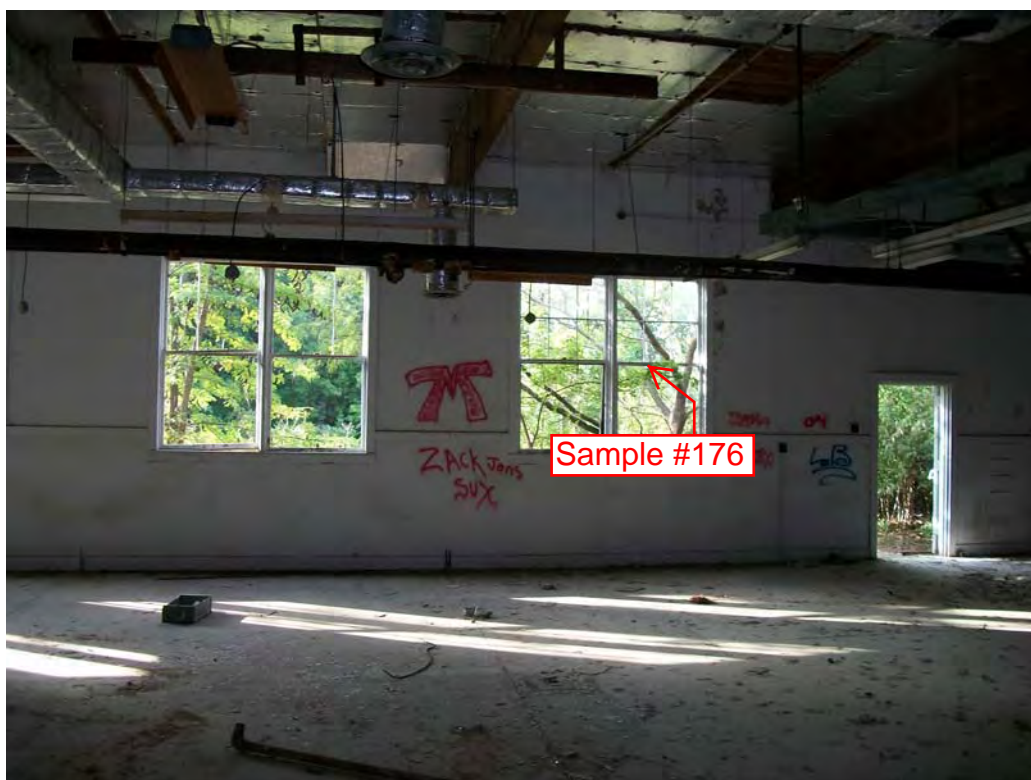
Photo 29 ►

Building 552 - Room 1.

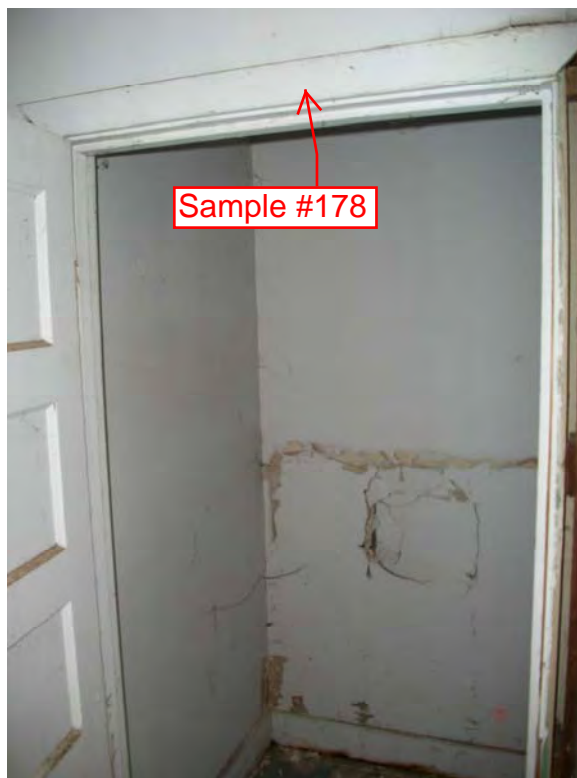
Photo 31 ►

Building 552 - Room 4.

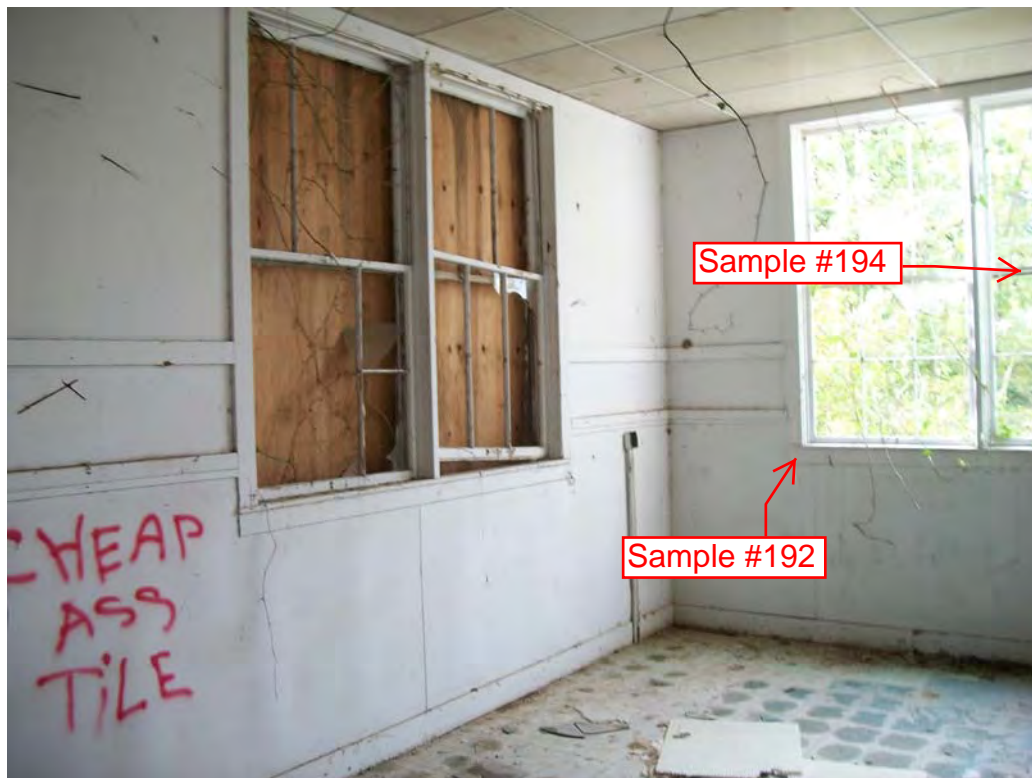
Photo 32 ►

Building 552 - Room 4.

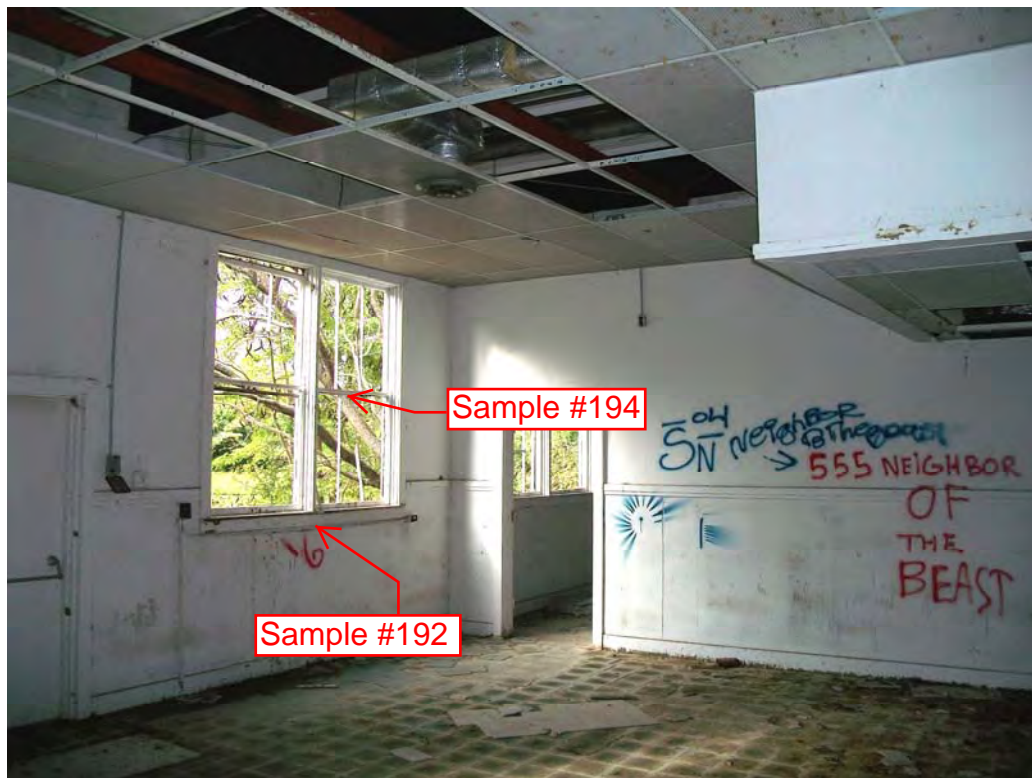
Photo 34 ►

Building 552 - Room 6.

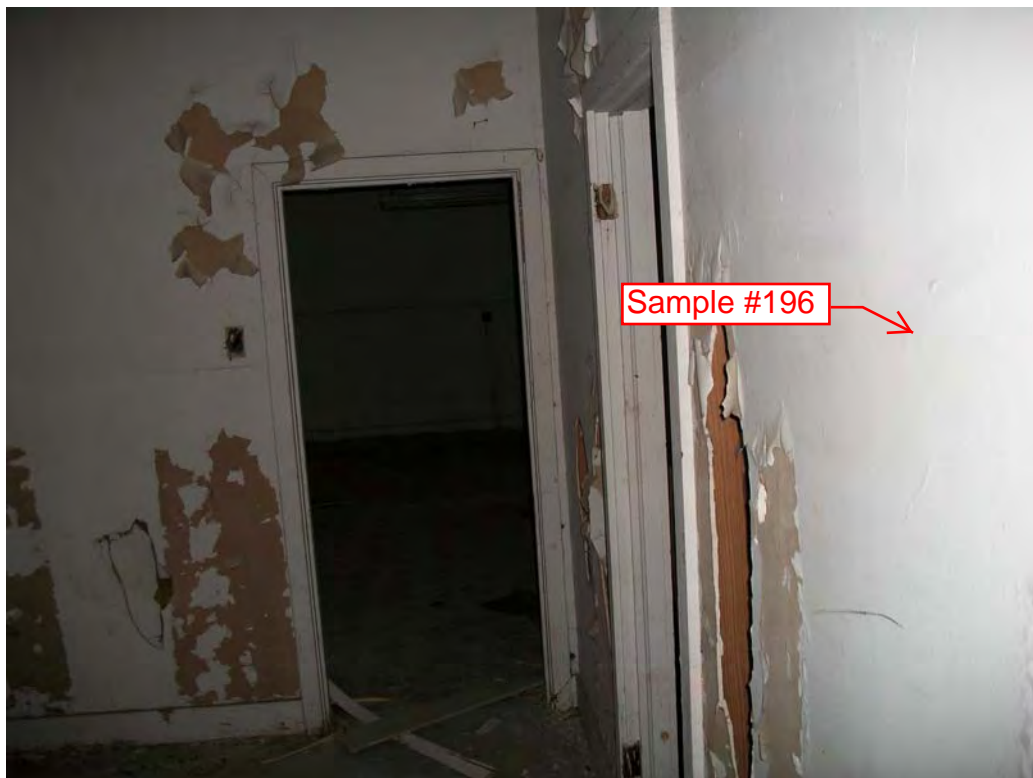
Photo 36 ►

Building 552 - Room 8.
